JDH Inspections LLC

PROPERTY INSPECTION REPORT

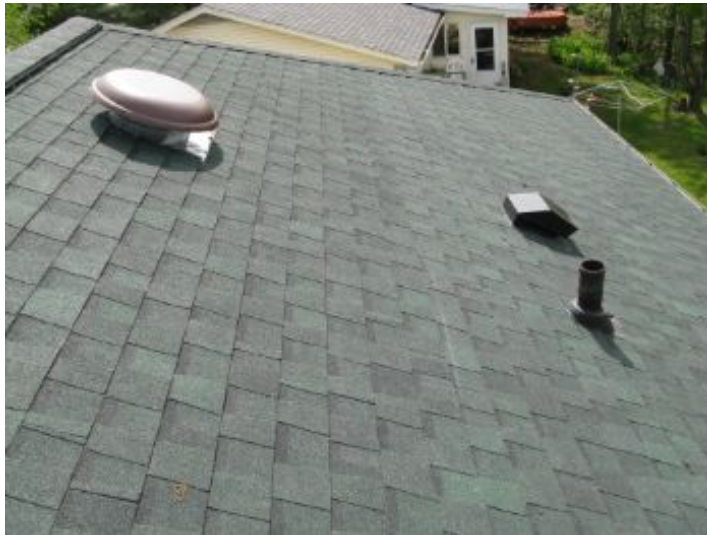
- Roof appeared functional at time of inspection. Owner stated it was a new roof in 2011.

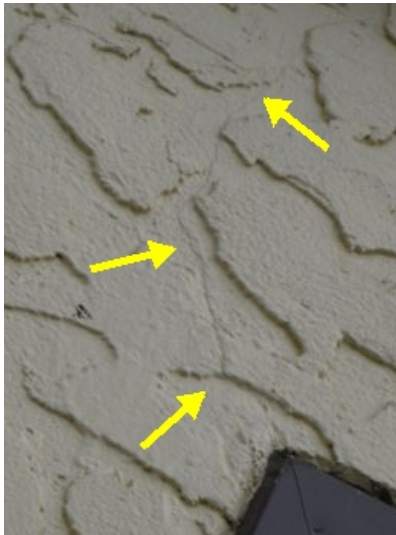
Hairline crack noted.

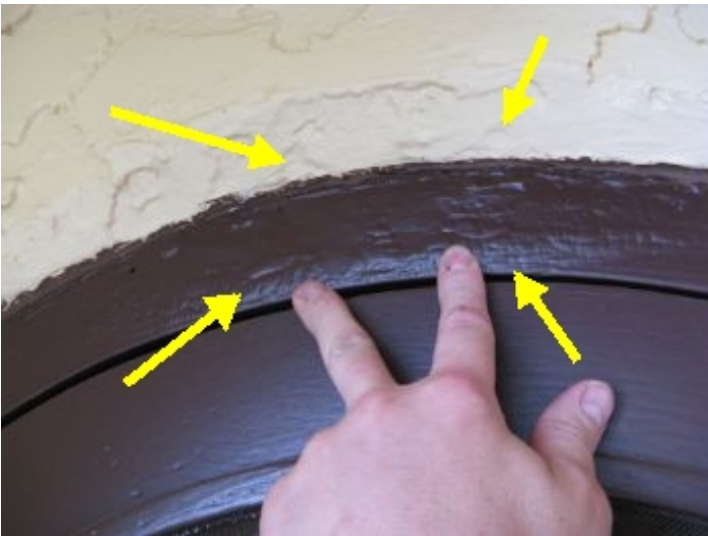
Bubbled paint over front entry door.

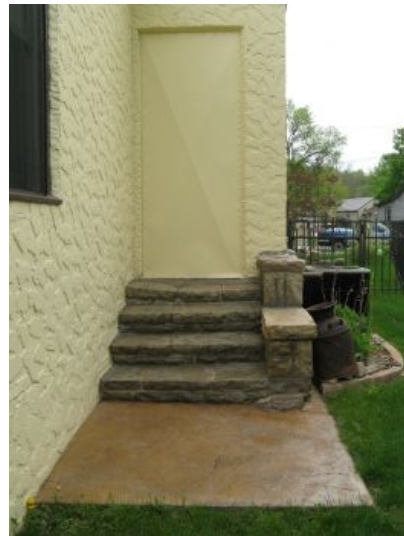
C. Windows condition

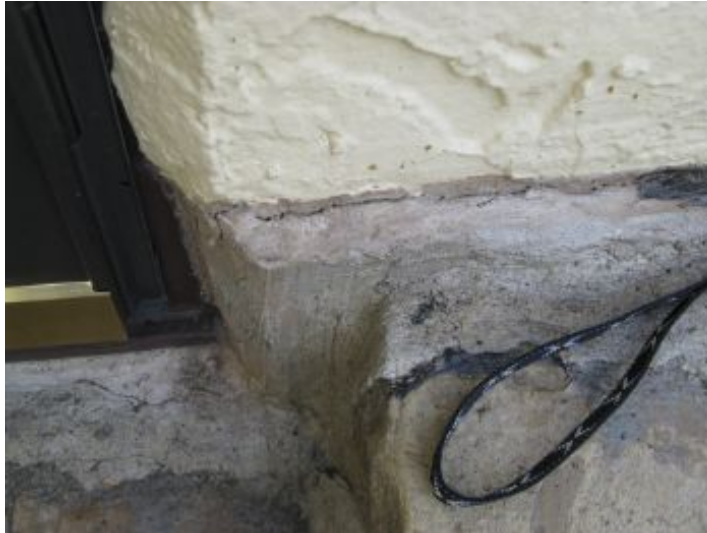
G. Exterior living space

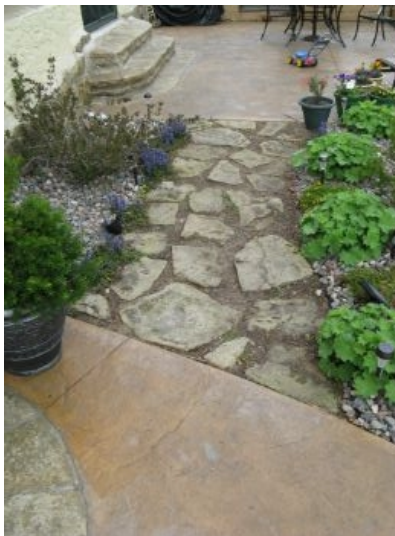
Possible trip area. Recommend repair to make more level.

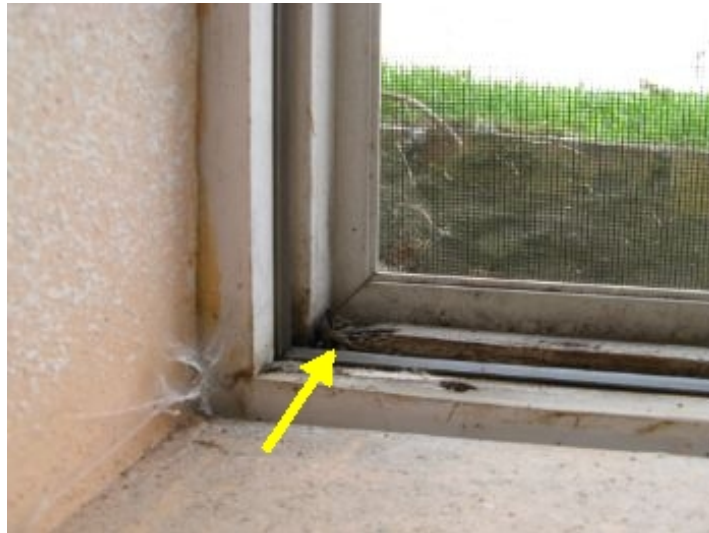
Basement bedroom window. Wood damaged in this area. Recommend repair to gain weather tight seal.

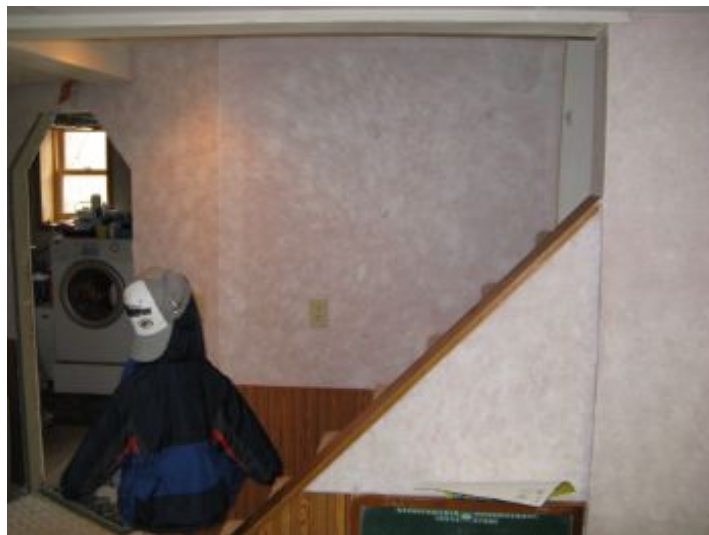
Open side of stairway. Recommend railing and or/ balusters.

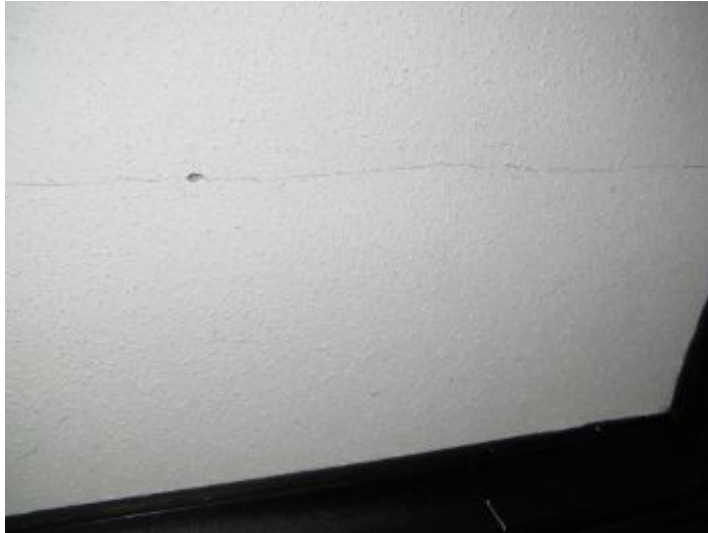
Some settlement cracks noted at time of inspection in living and dining rooms. Recommend monitoring and repairing as needed.

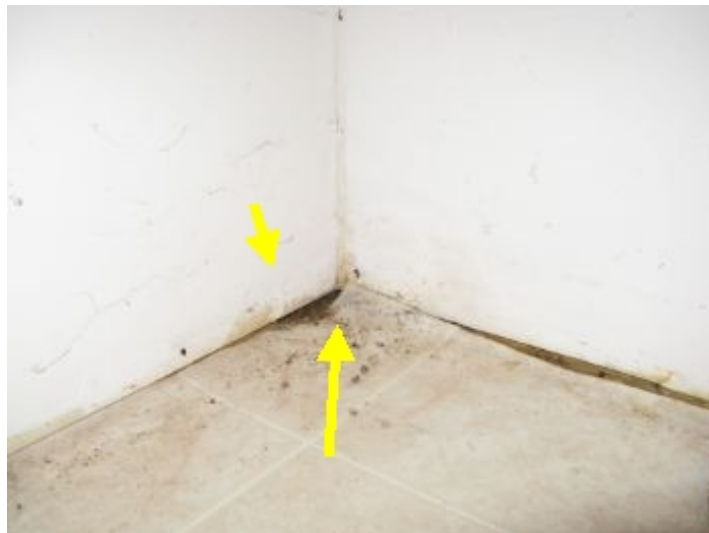
Moisture was noted at time of inspection in basement bathroom closet corner.

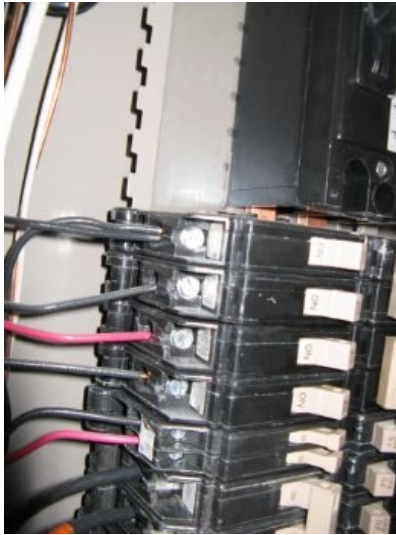
Double tap breaker. Recommend repair.

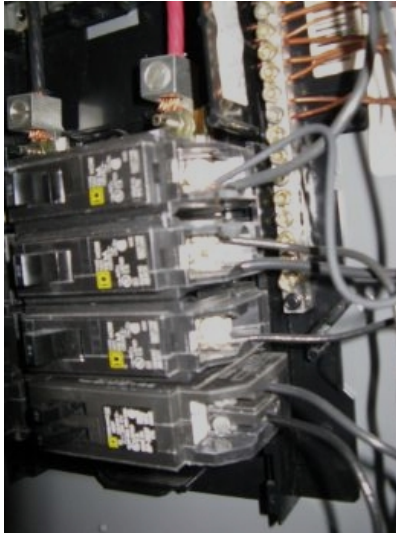
Double tap breaker in remote panel. Recommend repair.

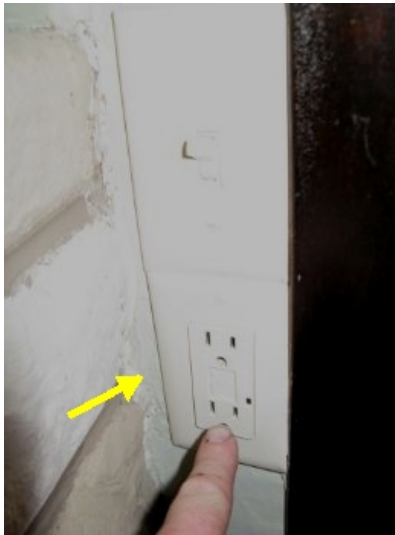
Outlet was found to be possibly wired wrong.

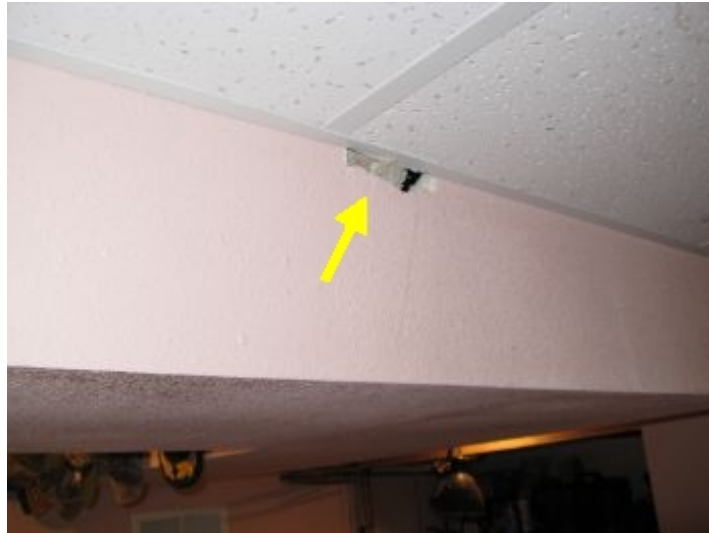
Possible asbestos noted at time of inspection.

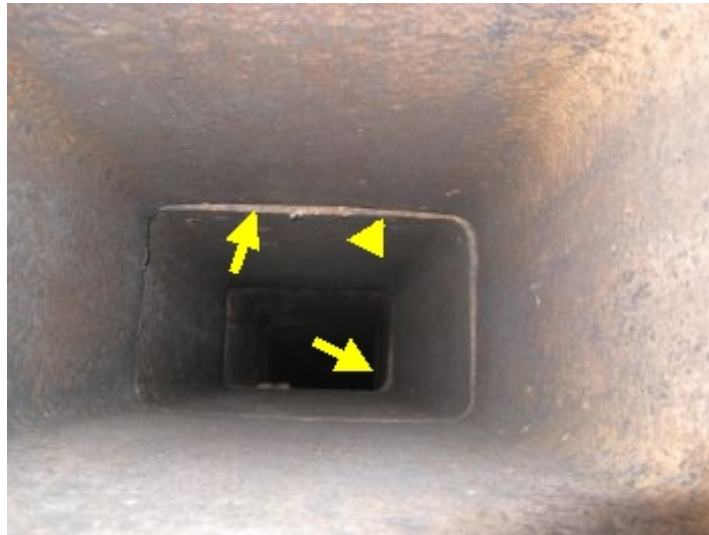
Appeared to be a gap or misalignment.

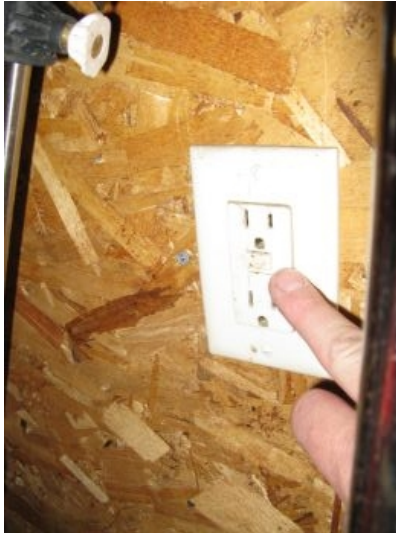
Outlet not working at time of inspection.
